THE HEXAGON (Ephraim Shay House) Harbor Springs, Michigan

Tech Notes

NUMBER 3

In-Kind Replacement of Historic Stamped Metal Exterior Siding

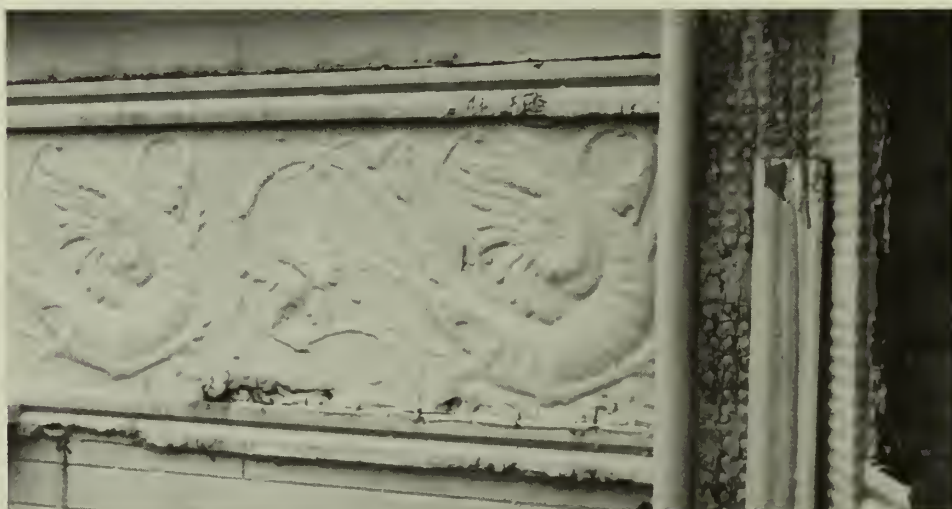
The house had been poorly maintained for several decades and, more recently, had been unoccupied. The asphalt shingle roof that replaced the original standing seam metal roof leaked badly, allowing water to penetrate into the wall cavities behind the stamped metal siding. Due to neglected repairs and cleaning, the original drainspout system failed to divert rainwater away from the house (*see figure 3*). In some places, rainwater

3. Stamped metal siding simulating brickwork covered most of the exterior of the house. Pebbled corner pieces and several ornamental bands added decorative details. Deteriorated drainspout and original plank wall sheathing are at right. Photo: Richard Hiler.

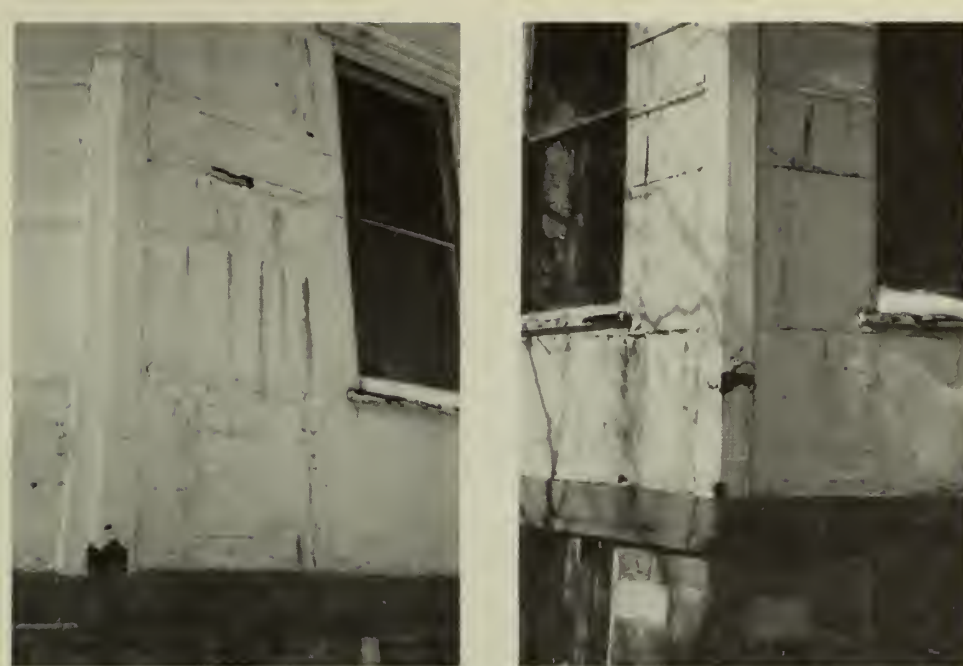
Although the original galvanized (zinc-coated) steel and zinc siding had been back-primed, long-term water infiltration caused the siding to corrode from the inside toward the face. The location of the building at Little Traverse Bay also contributed to the slow deterioration of the siding. In extremely deteriorated areas, the metal had been reduced to an easily breakable, crusty mass. An assessment of the exterior revealed that nearly 90% of the stamped siding had moderately or severely deteriorated to the point that replacement was required (see figure 4). Since only a small percentage of the siding was salvageable and all needed to be removed to facilitate other project work, the decision was made to replace all of the metal siding.

4. Rust stains indicate where corrosion, caused by water infiltration, are breaking through the metal from the rear. Rust and separation are also evident at seams between sheets of stamped metal. Inspection determined that nearly 90% of the stamped metal siding had to be replaced. Photo: Richard Hilner.

Five exterior sheet metal patterns required replacement: the brick pattern that covered more than half of the exterior, two ornamental band patterns, the wall corner pattern, and the molding that separated the ornamental bands from the brick pattern (see figure 5).

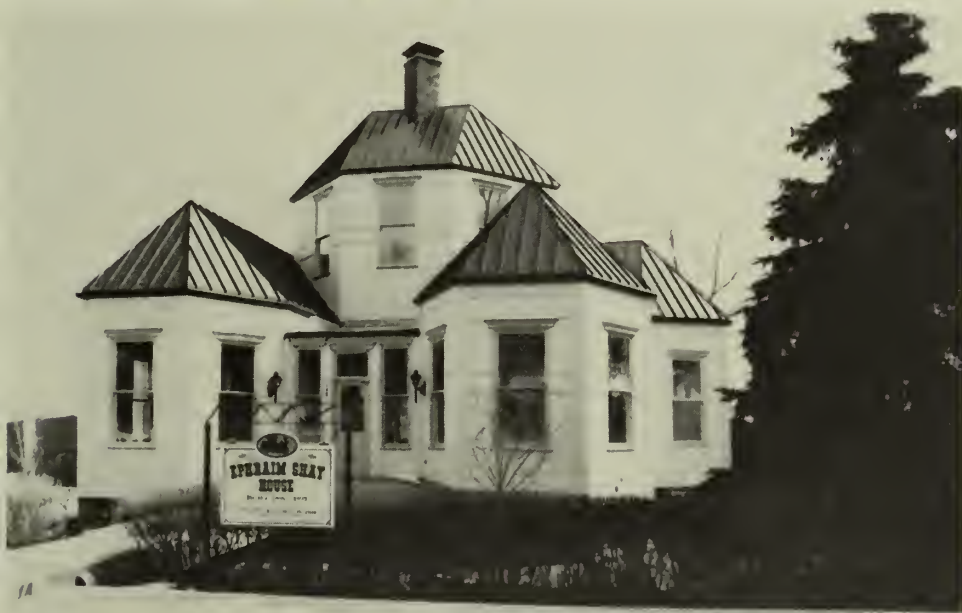
12. The replication of the stamped metal siding has restored the Hexagon to its historic appearance. A new metal panel roof system that duplicates the appearance of the original standing seam roof also contributes to the restoration. Photo: Richard Neumann.

The work on the Hexagon also demonstrates that custom pressed metal work can be both the practical and the appropriate preservation solution for even small projects where historic stamped metal siding is an important feature of the building (see figure 12). When special molds are necessary to duplicate a specific pattern, additional planning time may be required. However, stock patterns, such as the simulated brick siding on the Hexagon, may be available, allowing for quicker delivery and cost savings. Properly prepared, finished, and maintained, galvanized and zinc pressed metal can have a long useful life.
